**Measurement Risk
(Measurements gone wrong)**

Henry Zumbrun, Morehouse Instrument Company

Hosted by PJLA- Tracy Szerszen, President

**September 28, 2023
1:00-2:00 PM EST**

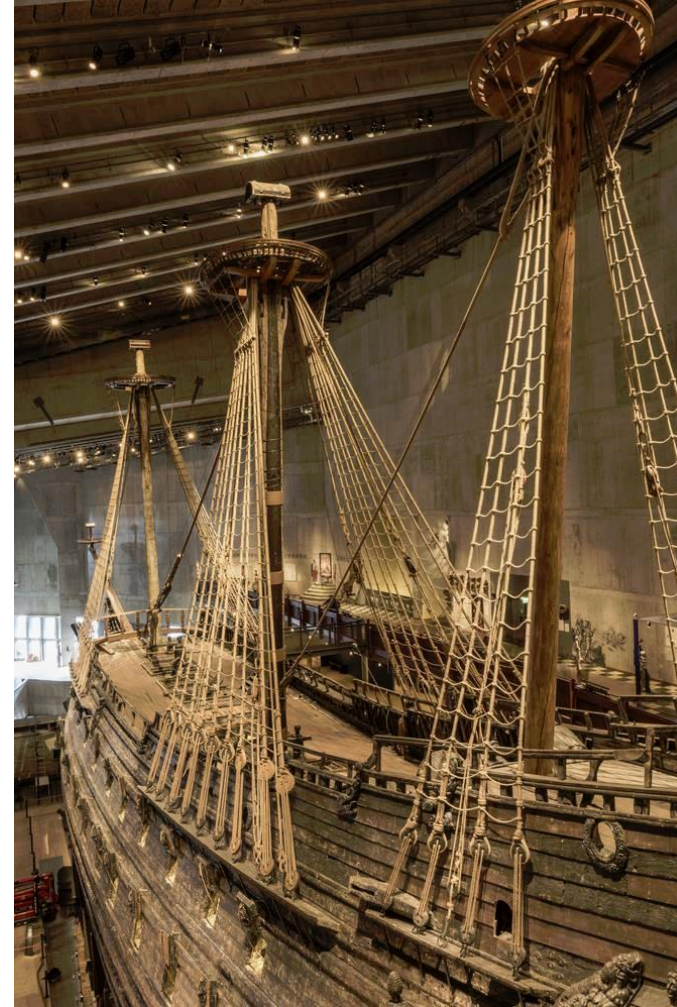
- ▶ The Swedish warship Vasa, which famously sank in 1628 less than a mile into its maiden voyage, was built asymmetrically.
- ▶ Archaeologists have found four rulers used by the workers, two turned out to be based on Swedish feet with 12 inches (30.48cm). The other two used Amsterdam feet, with 11 inches (27.94cm).

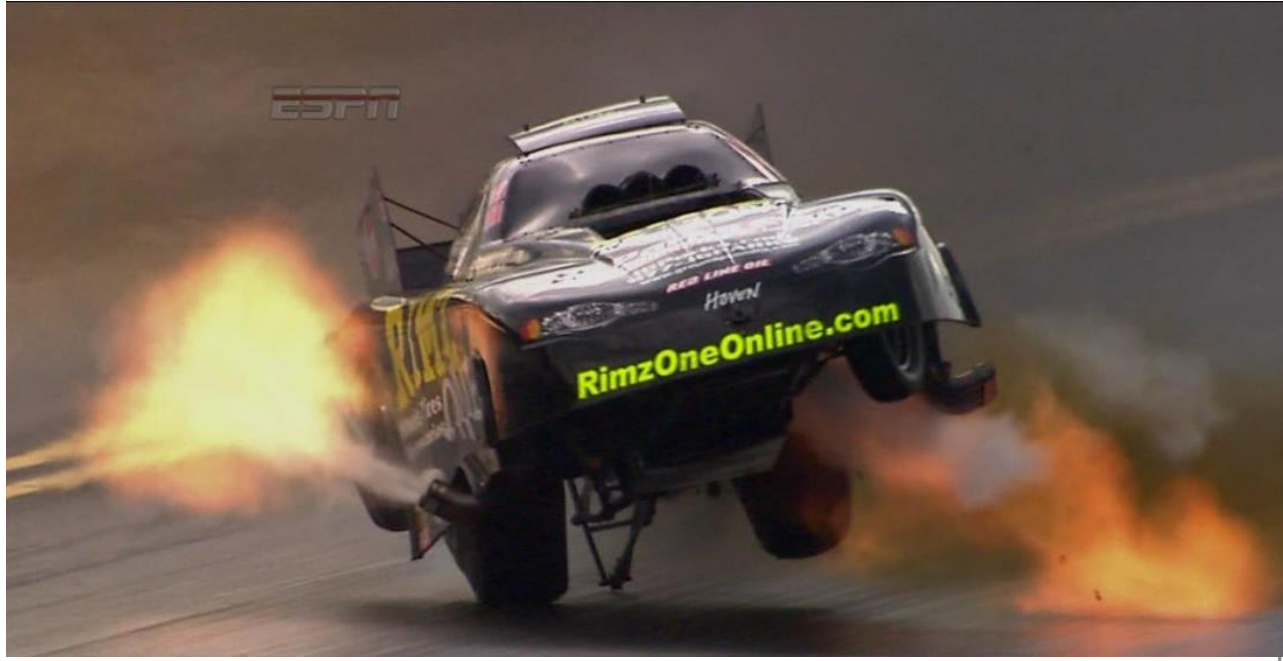
- ▶ If the tension is too high, the tightening process may cause bolt failure.

Pictured Above: Metal snap from Jeff Nihel's dragster, apparently the bolts on the left exhaust manifold were over-torqued... bolts then failed, manifold popped off and 4000bhp of exhaust gas launches the car in the air at over 200mph!

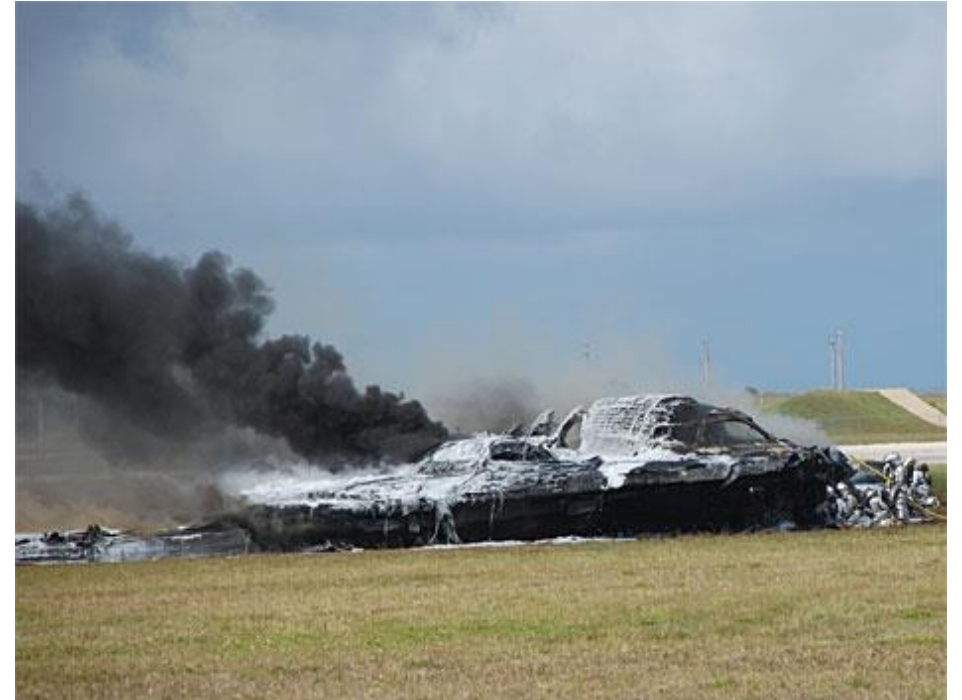
- ▶ This mixture of water and fuel caused condensation to build up on the sensors which were near the planes surface. When maintenance crew were calibrating them before the flight, they were unaware of this build up **causing them to calibrate them wrong.**
- ▶ **It's only a 2 billion dollar mistake**

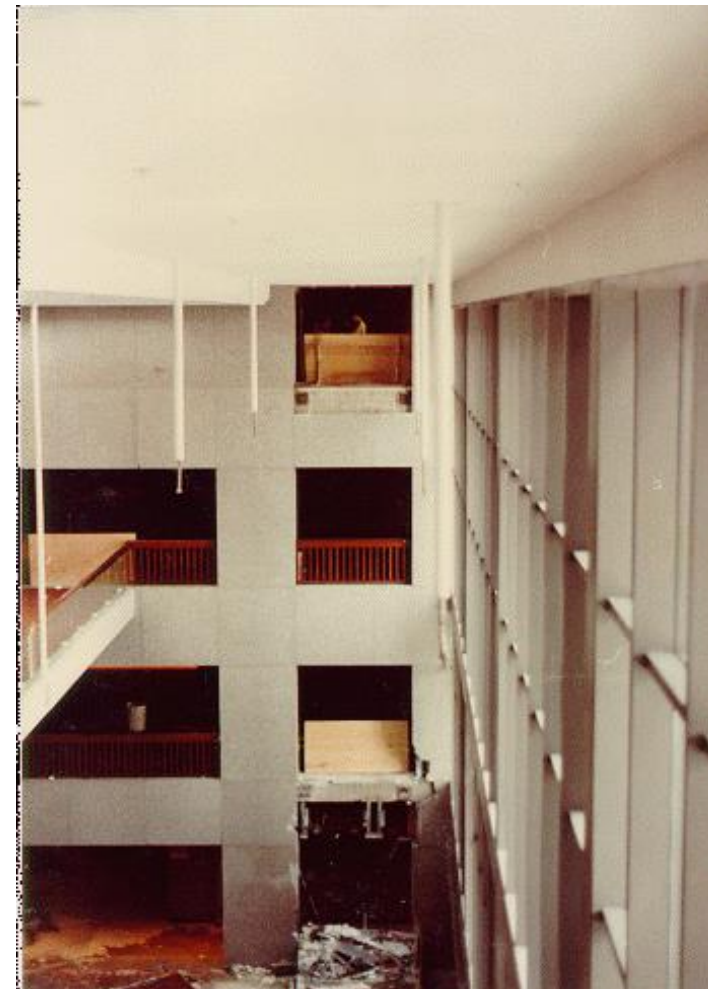
On July 17, 1981, the Hyatt Regency Hotel in Kansas City, Missouri, suffered the structural collapse of two overhead walkways. Loaded with partygoers, the concrete and glass platforms cascaded down, crashing onto a tea dance in the lobby, killing 114 and injuring 216. Kansas City society was affected for years, with the collapse resulting in billions of dollars of insurance claims, legal investigations and city government reforms.

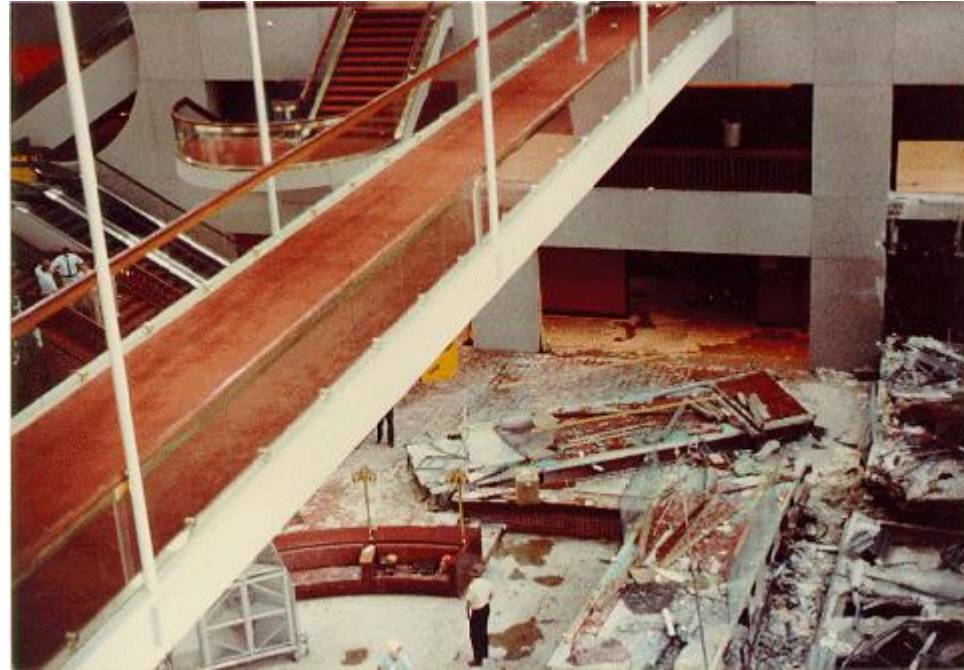
An investigation concluded that it would have failed even under one-third of the weight it held that night. Convicted of gross negligence, misconduct, and unprofessional conduct, the engineering company lost its national affiliation and all engineering licenses in four states, but was acquitted of criminal charges

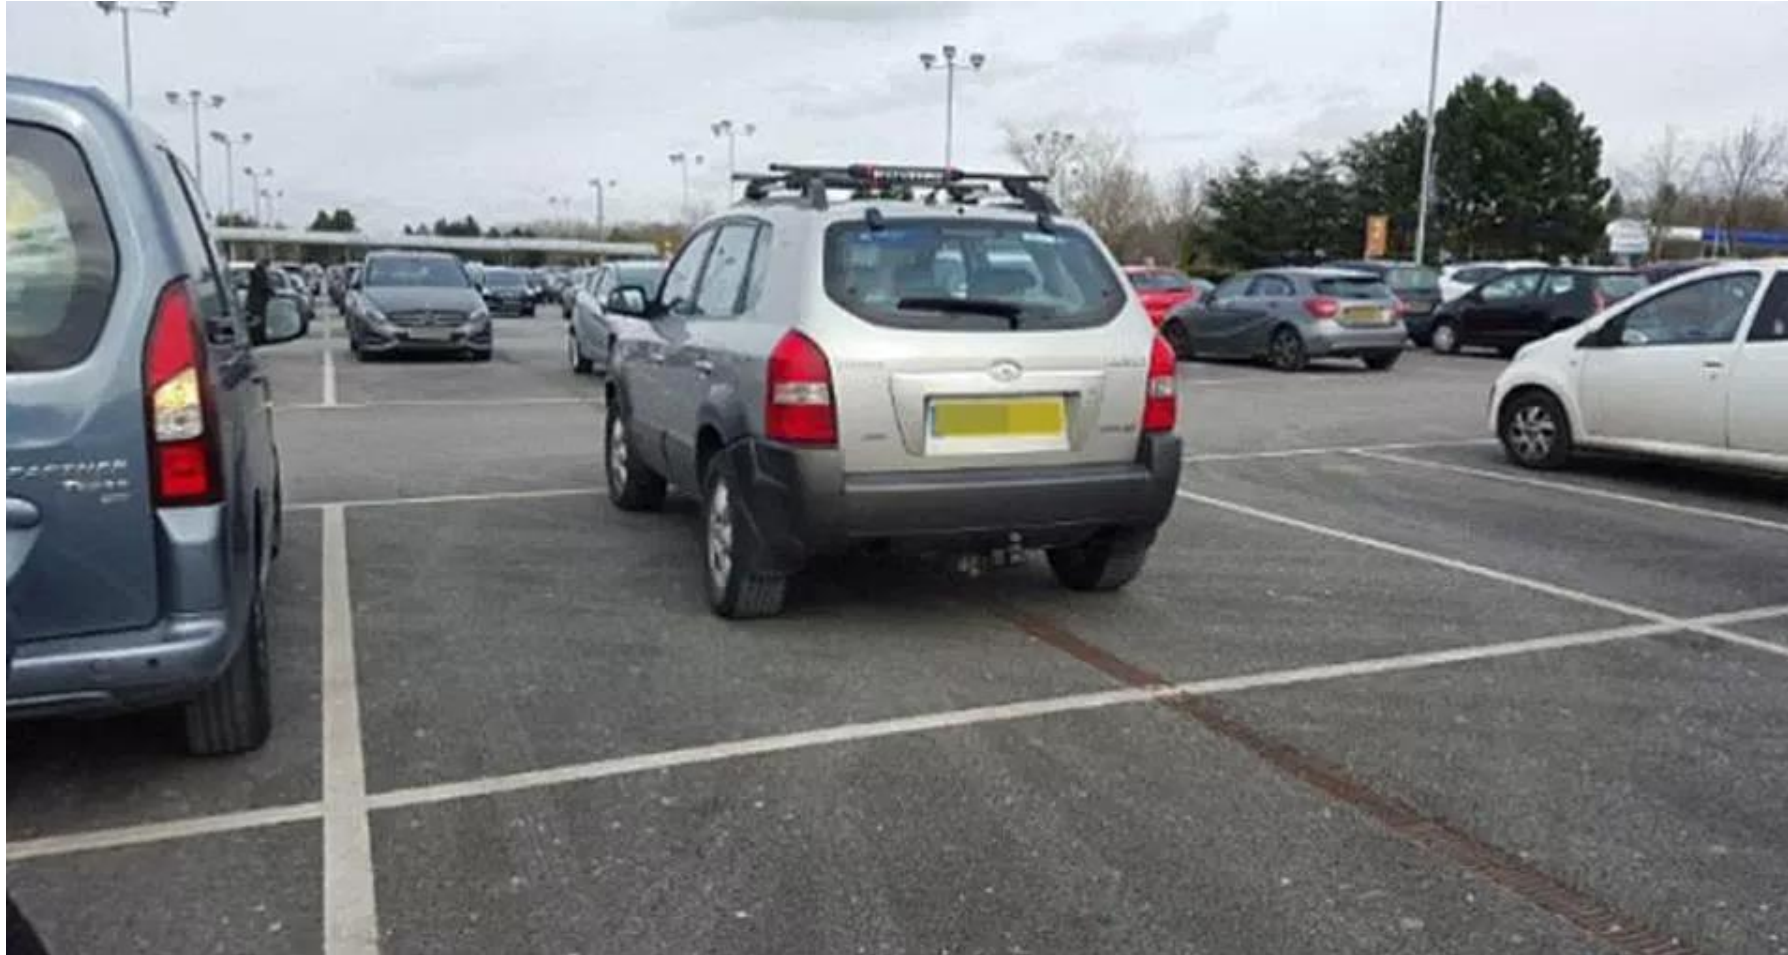
The larger the TUR (Smaller MU), the more room you have!

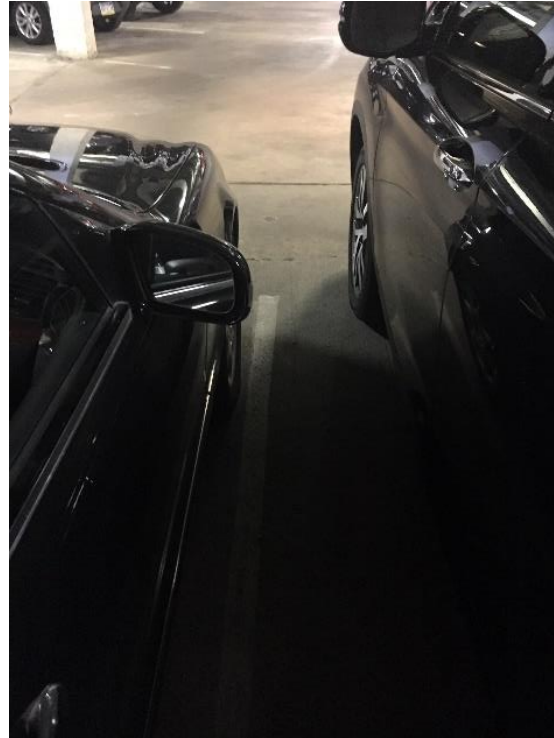
The lab with the larger uncertainties will produce smaller TUR's, giving you less space to be in tolerance!

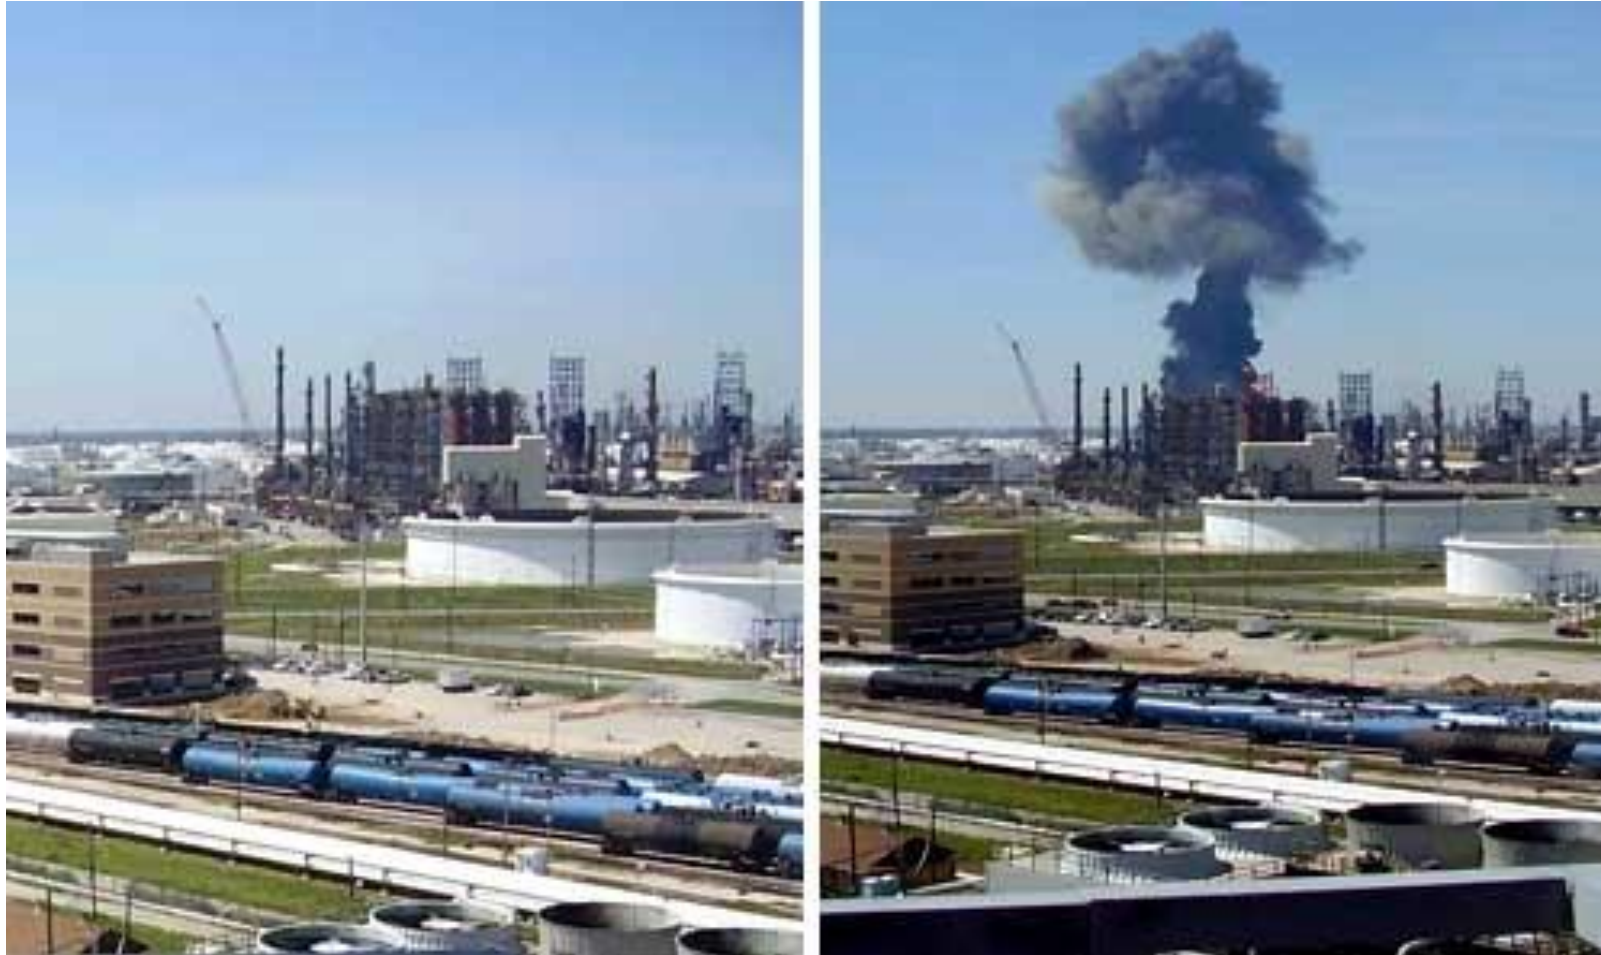
BP Texas Refinery Moments before and immediately after the explosion

- ▶ Distillation tower and attached blow down drum overfilled
- ▶ ~7600 gallons flammable liquid released
- ▶ Liquid ignited by an idling diesel truck

- ▶ High-level alarm malfunctioned
- ▶ Level transmitter miscalibrated
 - Outdated 1975 data sheet
 - Level transmitter indicated liquid level falling
 - Level actually rising rapidly

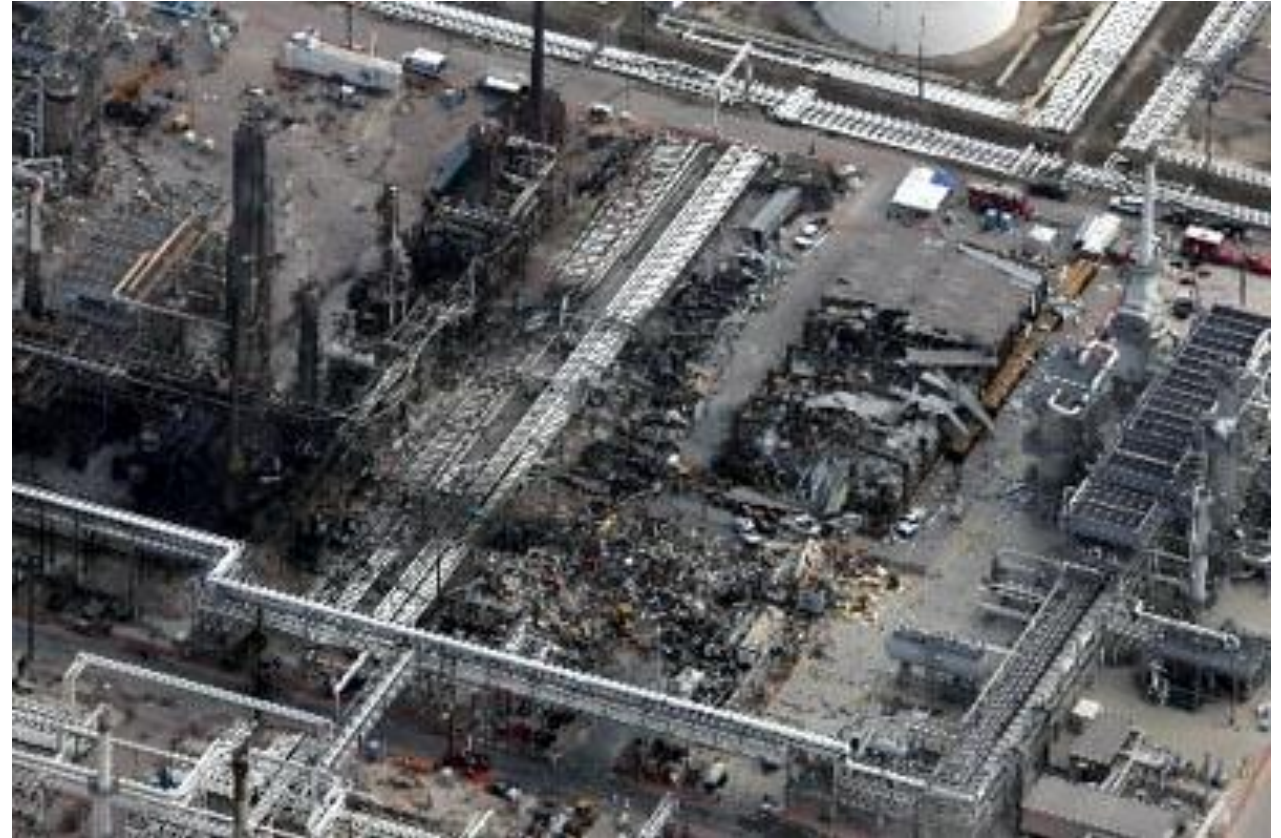
- ▶ Cost-cutting, production pressures, and failure to invest
- ▶ Lack of preventative maintenance and safety training
- ▶ Procedural workarounds to compensate for the deteriorating equipment

- ▶ 15 deaths,
- ▶ 180 injured
- ▶ Over \$2 billion, including lawsuits

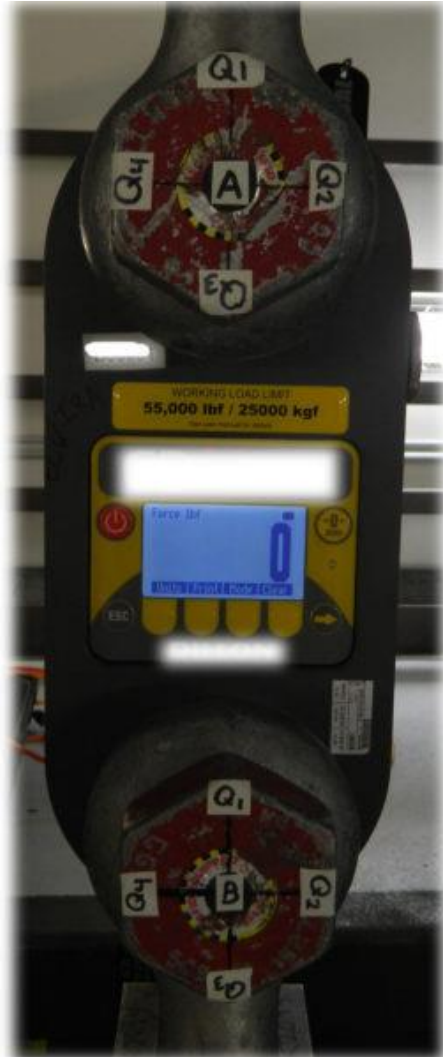
Pin B (2.0030 to 2.0060)	Pin A (2.0005 to 2.0045)
50,070	50,010
50,050	50,020
50,040	50,010
50,070	50,020
50,090	50,020
50,060	50,030
50,080	50,010
50,070	50,030
50,090	50,020
50,090	50,070
50,080	50,060
50,100	50,070
17.81640375	22.74696117
Out of 24 tests 13 did not meet spec ± 50

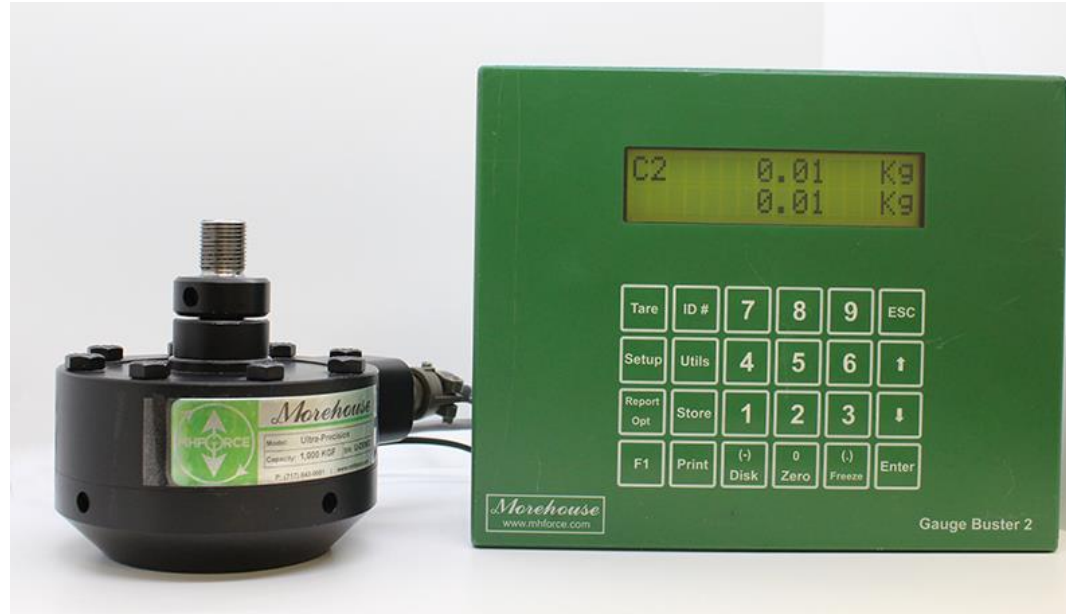
Here we set the resolution to 0.01. What might happen if the resolution were set to 1?

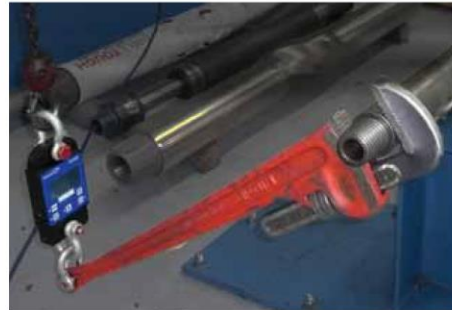
A large display and an audible alarm let workers know when the optimal torque has been reached.

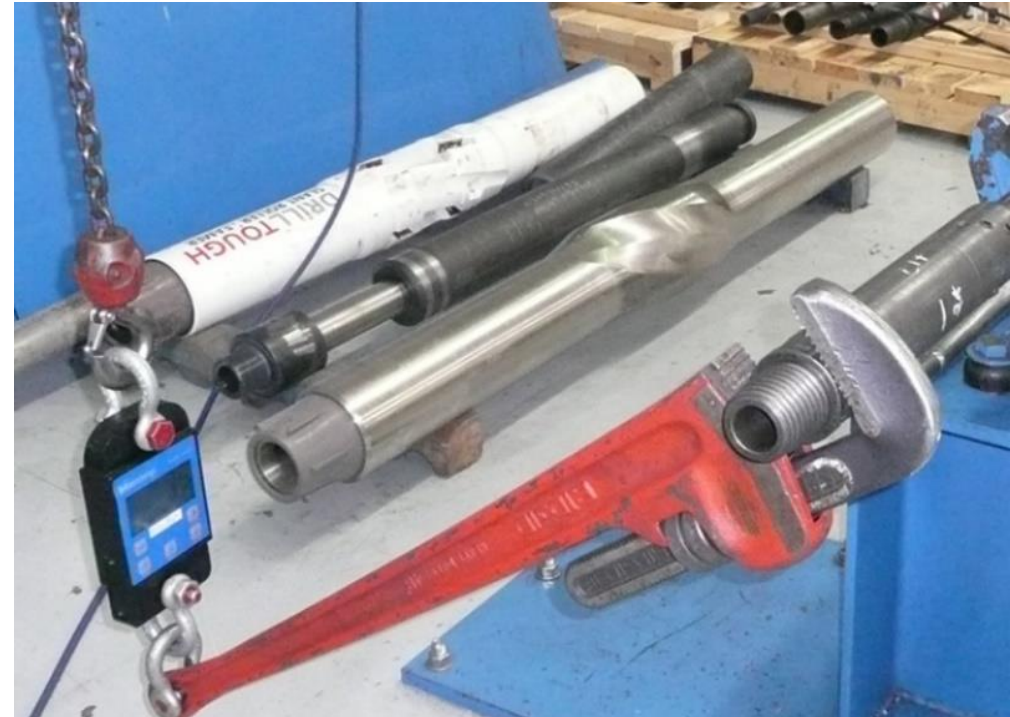
Torque= lift force x Sin(t) x wrench length
t = angle and assuming 45 degrees based on visual from picture, sine would be square root of 2 divided by 2 or about 0.71 (This equate to about 29 % error in the torque measurement). If the angle where 90 degrees the sine error goes away.

Is this a good way to accurately measure torque?

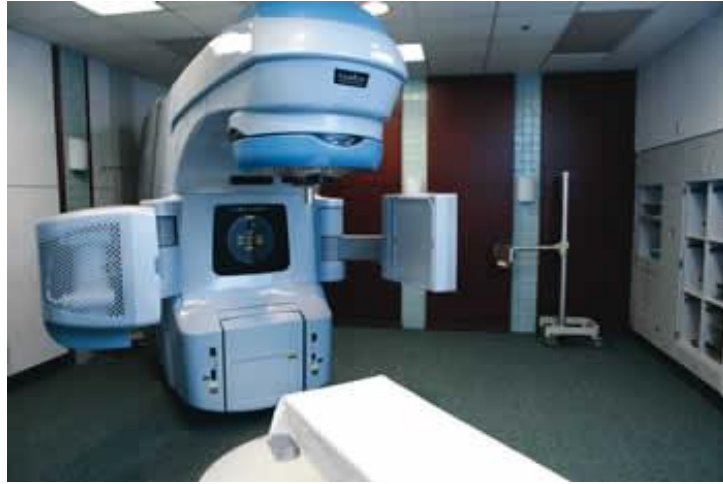
- ▶ CoxHealth of Springfield, MO inadvertently overdosed 152 cancer patients, 76 of which received up to 70% higher than prescribed dosages
- ▶ The device, a BrainLAB stereotactic radiation system used to treat areas 1.1 centimeters or smaller, was initially incorrectly calibrated by the CoxHealth chief physicist in 2004
- ▶ The error went undetected for five years, until September 2009 when another CoxHealth physicist received training on the BrainLAB system
- ▶ Although the calibration error was corrected, as of February 2012, the CoxHealth BrainLAB program remains suspended while lawsuits are settled

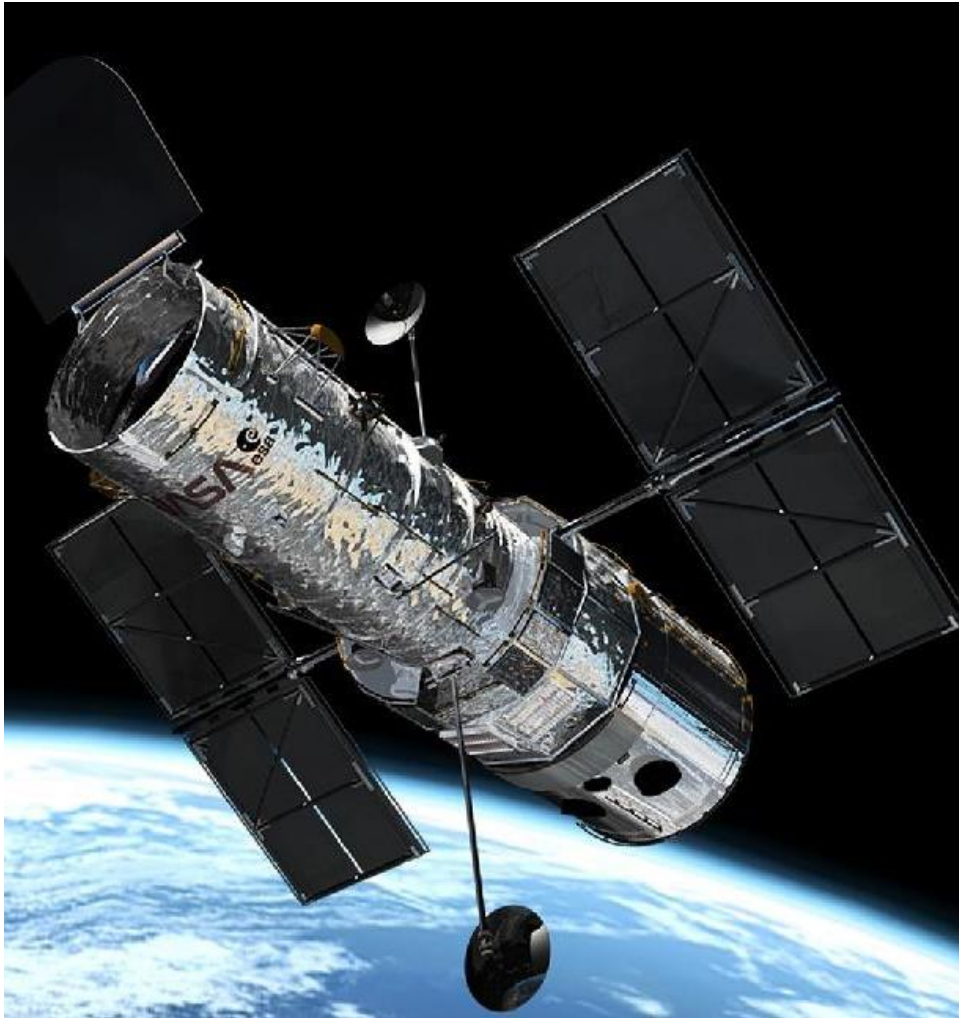
- Hubble Space Telescope (HST) launched April 24, 1990
- On-orbit checkout revealed HST could not be properly focused
- Ensuing investigation indicated the primary mirror was not built to specifications
- A servicing mission to correct the error was flown in December 1993 at a cost of over \$1 billion USD

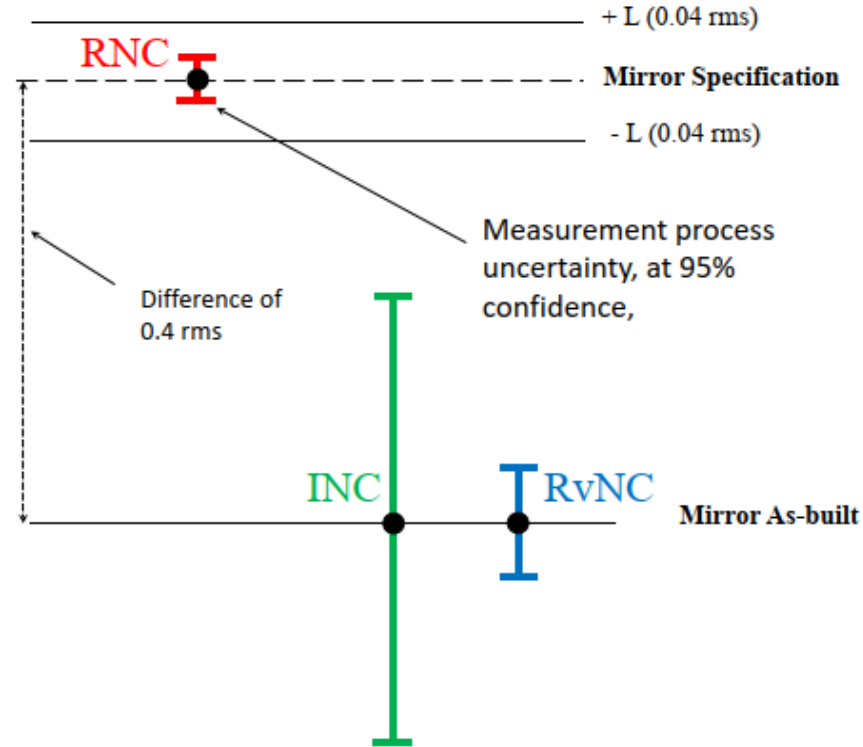
RNC: Reflective Null Corrector. Designed and built by Perkin-Elmer, the manufacturer of the primary mirror.

RvNC: Refractive Null Corrector. Standard for producing primary telescopes.

INC: Inverse Null Corrector. Designed to simulate a perfect mirror as a check for the RNC.

- Error was ten times specification
- The optical test used to manufacture mirror was set-up incorrectly
- The **RvNC** and **INC** clearly showed the error, yet both were discounted
- There was a mindset to discount any independent measurements less accurate than the **RNC**
- Discounting the **INC** and **RvNC** data was, in essence, “shopping for the answer they wanted”

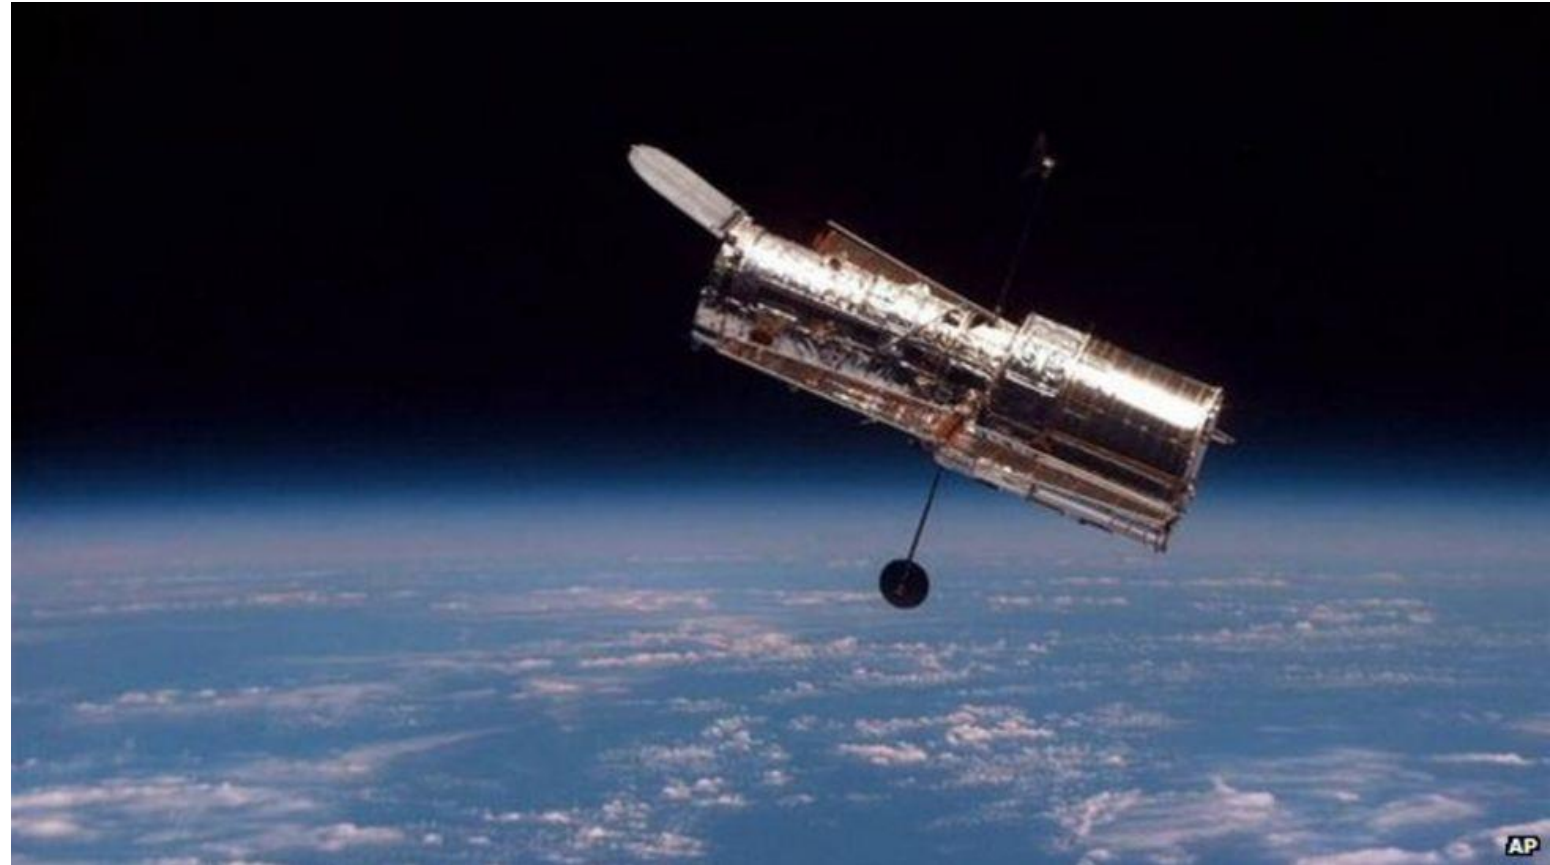
The internet theory is that a speck of paint on a device used to test the mirror resulted in distorted measurements. Luckily, scientists managed to fix the problem in 1993, using an instrument called the Corrective Optics Space Telescope Axial Replacement (Costar).

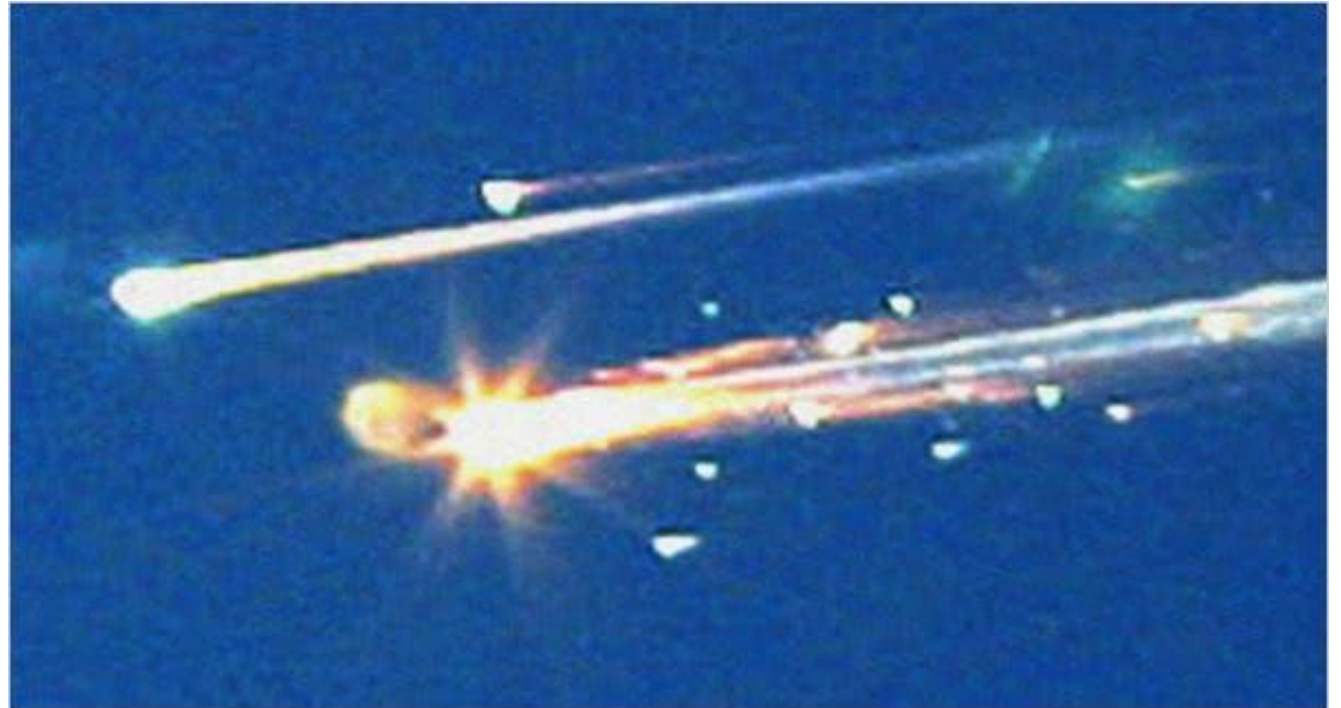
- ▶ Research showed that despite the years of engineering and planning, the downfall could be attributed to a technical communication failure following the debris damage and prior to reentry. In simple terms, years of engineering work from the smartest minds the world has to offer were undone by a few PowerPoint slides

- The existing SOFI on tile test data used to create Crater was reviewed along with STS-87 Southwest Research data
 - Crater overpredicted penetration of tile coating significantly
 - Initial penetration to be described by normal velocity
 - Varies with volume/mass of projectile (e.g. 200ft/sec for 3cu. Ln)
 - Significant energy is required for the softer SOFI particle to penetrate the relatively hard tile coating
 - Test results do show that it is possible at sufficient mass and velocity
 - Conversely, once tile is penetrated SOFI can cause significant damage
 - Minor variations in total energy (above penetration level) can cause significant tile damage
 - Flight condition is significantly outside of test database
 - Volume of ramp is 1920cu in vs 3 cu in for test

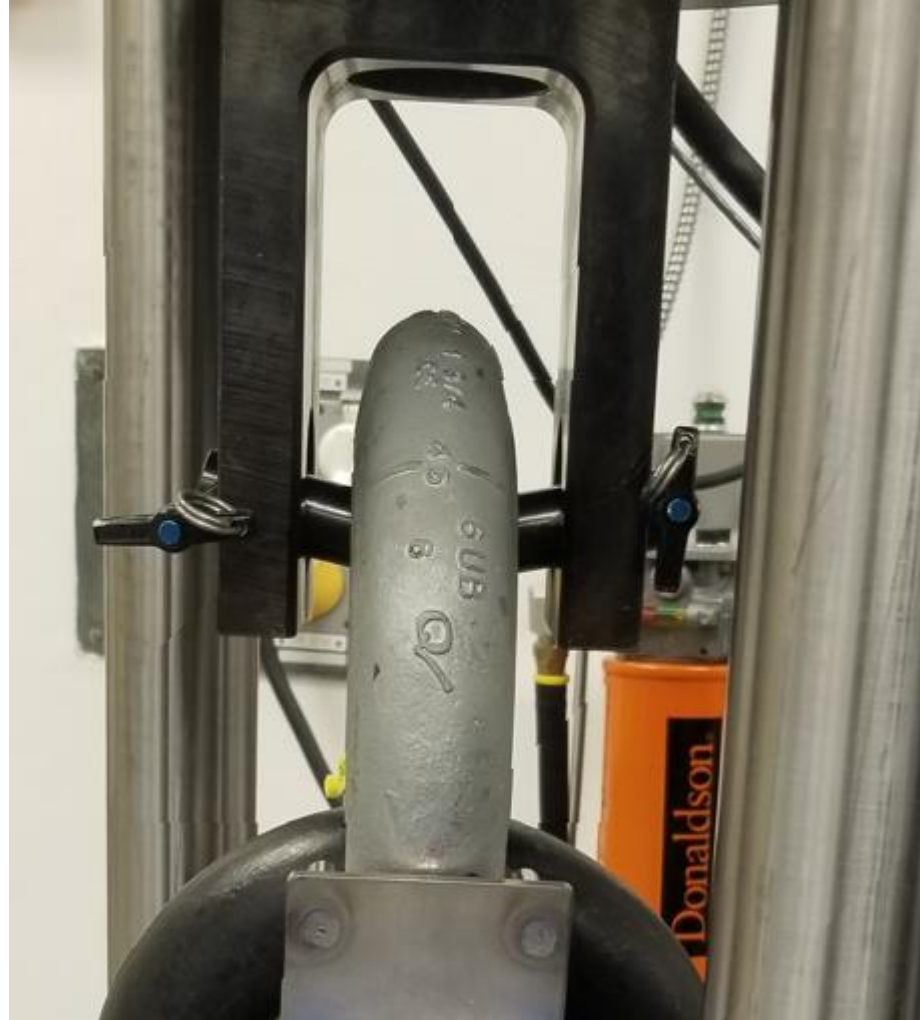
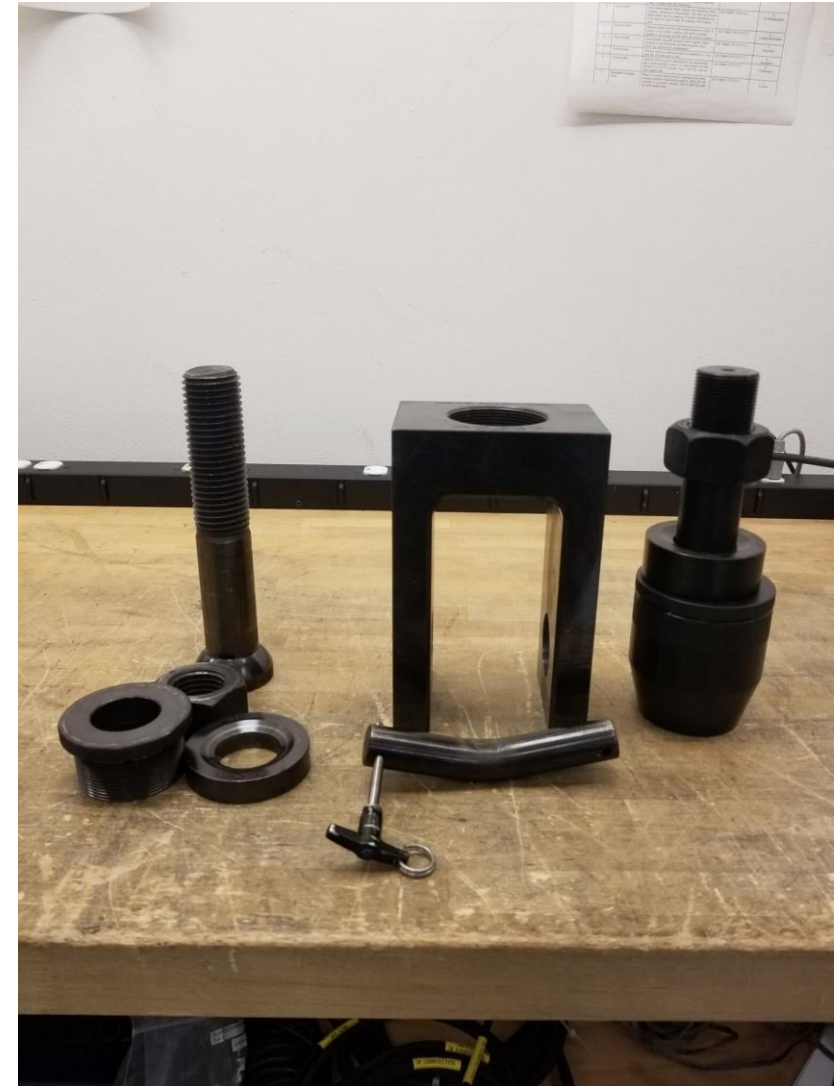
This is what happens when a smaller pin is used for a tension link or crane scale calibration and a driving force behind our Clevis adapters (Patent No. 11,078,052)
